Acid Solutions[®] Pty Ltd

CONTAMINATED BULK WATER TREATMENT

Environmentally sensitive community lakes treated for suspended solids contamination from construction works.

May 2008

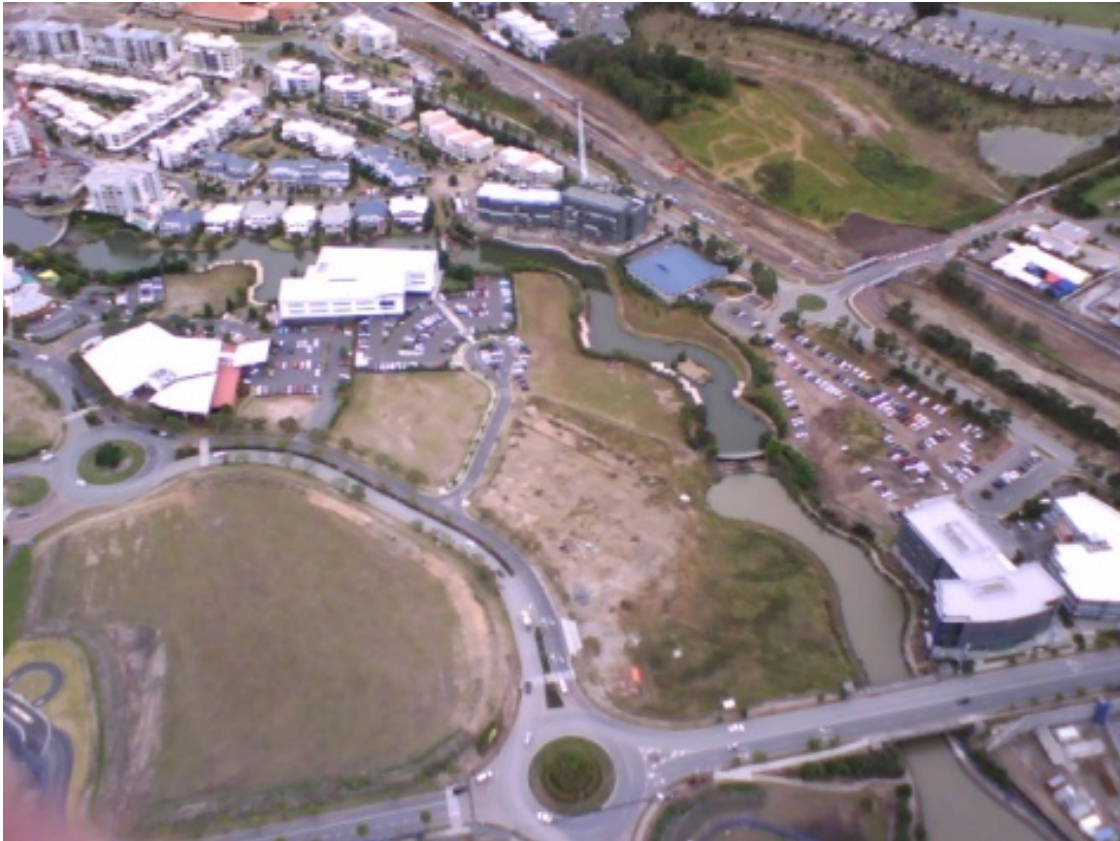
Notice the lake in the bottom right of the picture above. Aerial photo was taken before this site was treated.

This latest advanced CRAB system, being highly portable & fast to set up, quickly and easily treated the 5 difficult sites without disturbance to the community and sensitive ecosystem.

48 Tonne of reagent was applied in 11 days with our specially designed environmentally sensitive applicators.

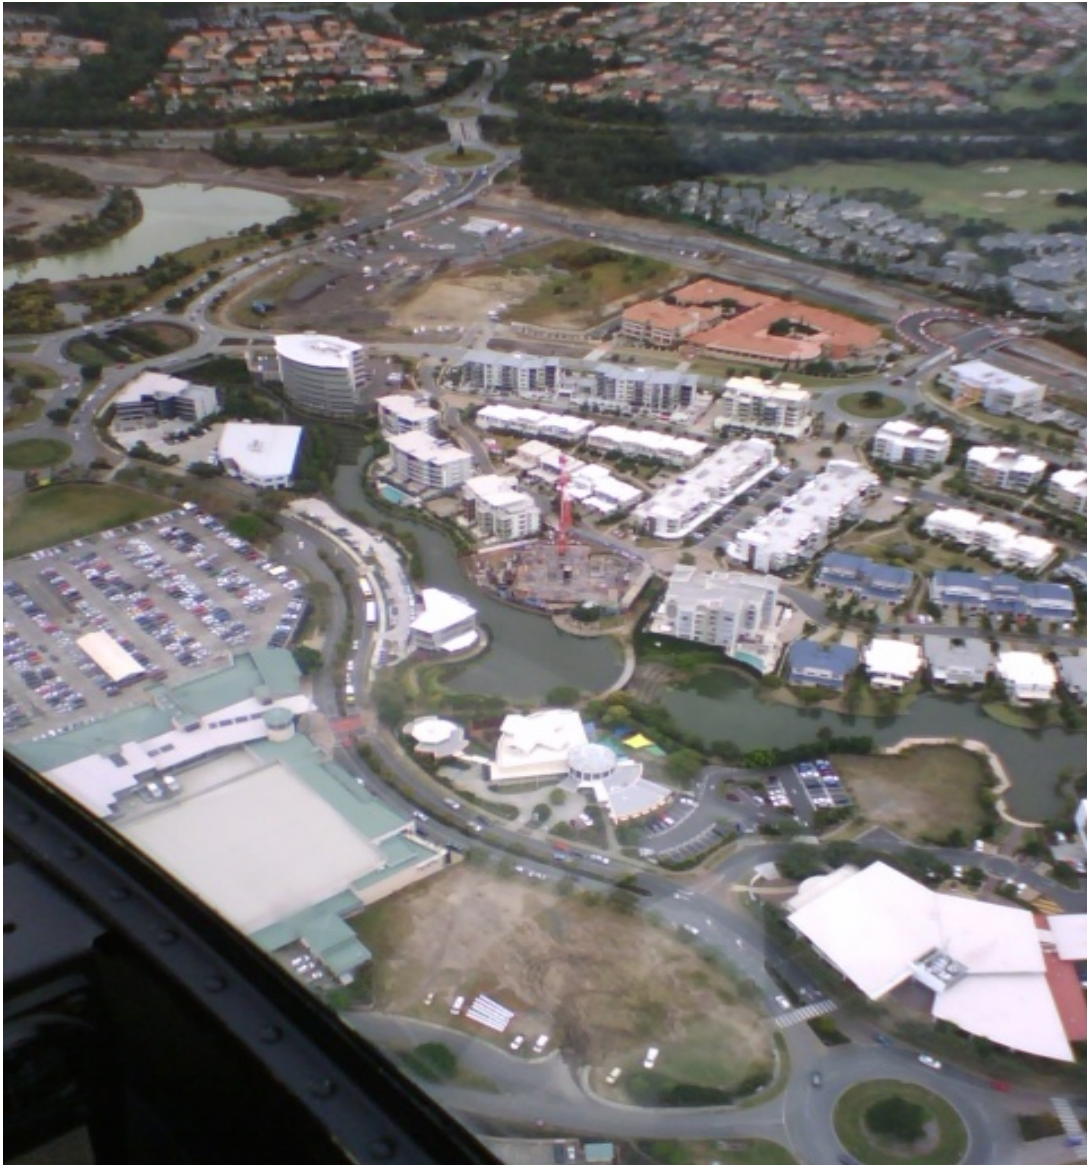
Aerial photo taken after treatment.

The application processes used by acid Solutions very effectively treated the high suspended solids. It ensured no harm or disturbance was caused to the aquatic flora and fauna as well as to the business and residential community as well.
