# Acid Solutions®

## Contaminated Water Treatment Services

**Highly contaminated water treated with the CRAB and inline bulk treatment system (IBTS) to match drinking water quality.**

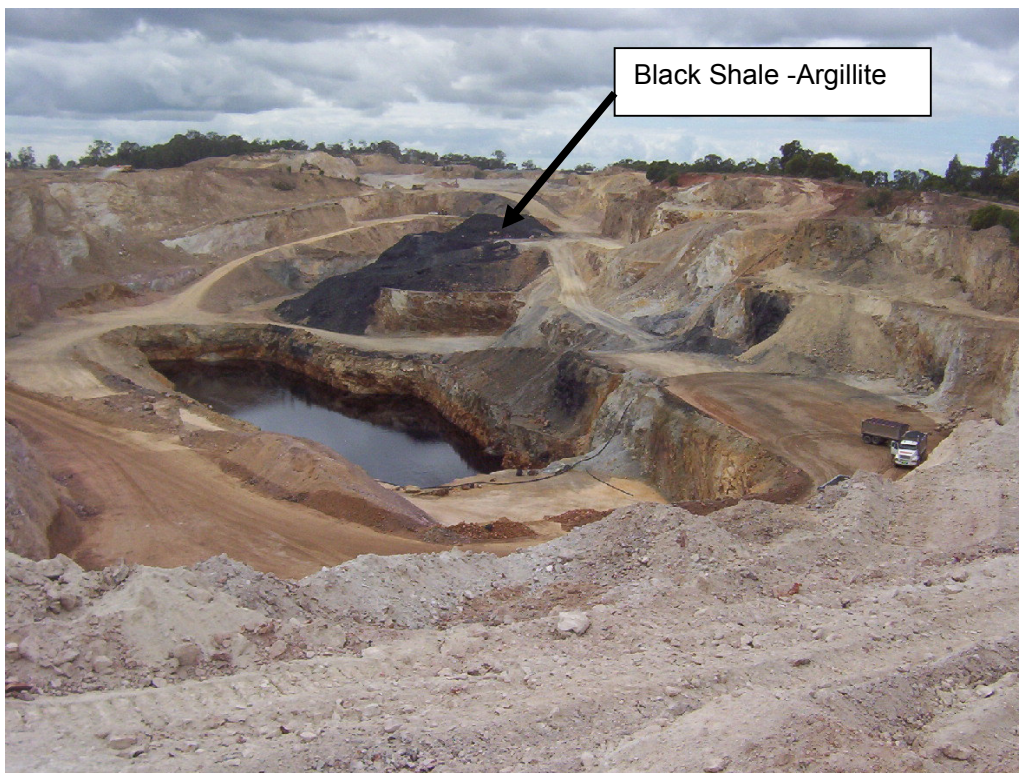
After heavy rainfall, the acidic water was pumped from the quarry to a holding pit for treatment. When this photo was taken, the pit had an acidity level of 3340 mg/l with extremely high dissolved metal loads, eg iron levels >600 mg/l.

The contamination of the water was mostly caused by a large and extremely acidic seam of Argillite (black shale).

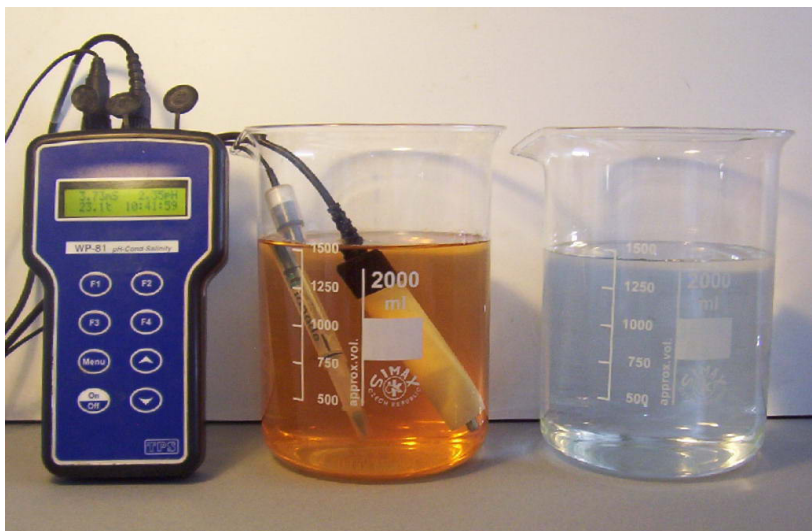
The difference between the raw pit water containing a high metal load and the pit water after treatment.

Inline treatment results	Raw Pit water	Treated to 8.8pH	Treated to 9.9 pH	ANZECC Drinking Limits	% metals removed
Ph	2.6	8.8	9.9		-
CaCO <sub>3</sub> Acidity	2090	-22	-94		-
Al Aluminium	130	7.8	25	0.2	94.00%
As Arsenic	0.39	<0.01	<0.01	0.007	97.43%
Cd Cadmium	0.030	<0.002	<0.002	0.002	93.33%
Cu Copper	33	0.08	0.07	2.0	99.78%
Cr Chromium	0.37	<0.02	<0.02	0.05	94.60%
Fe Iron Total	340	0.21	0.81	0.3	99.94%
Mg Magnesium	26	12	1.5	5.0	94.23%
Mn Manganese	7.9	0.16	0.02	0.5	99.74%
Ni Nickel	2.8	0.04	<0.01	0.02	98.57%
Zn Zinc	2.0	0.01	<0.01	5.0	99.50%
All results are measured in mg/l
